## Dimming of Compact Fluorescent Lamps Caused By Cold-Air Drafts

### The Situation

The New York World Trade Center occupies a 16-acre site with its own postal code. Its 110-story twin towers offer about nine million square feet of rentable office space, making it one of the largest commercial customers served by the New York Power Authority (NYPA). In 1997, the Port Authority of New York and New Jersey (PA), which manages the Trade Center, decided to replace over 1700 incandescent lamps in the lobbies of the twin towers with energy-efficient, 32-watt compact fluorescent lamps (CFLs). As part of its High-Efficiency Lighting Program (HELP), NYPA financed and coordinated the installation of the CFLs, ballasts, and fixtures in the twin towers.

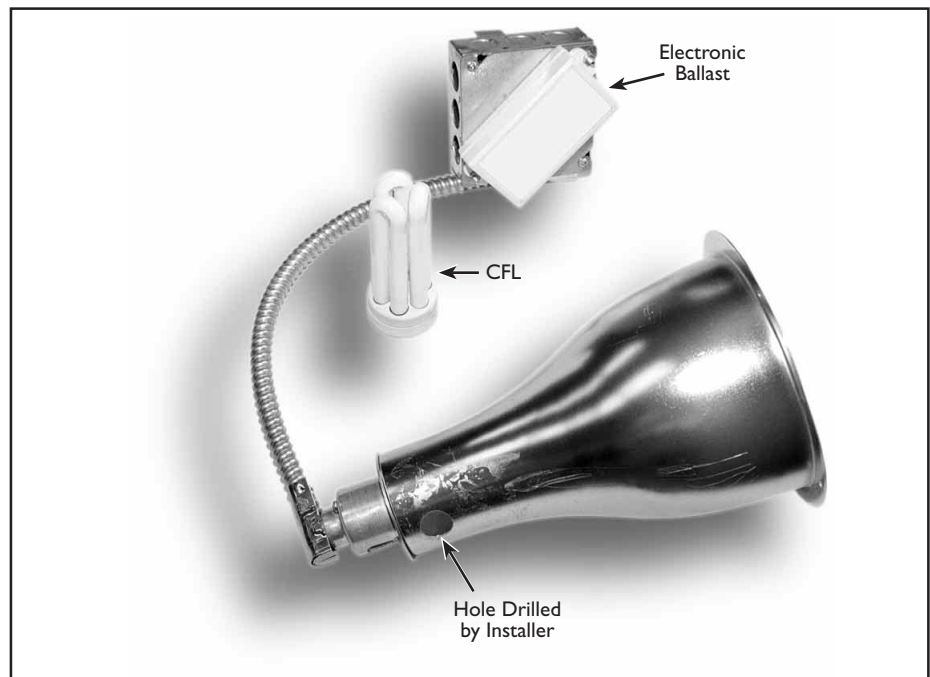
The canister fixtures—which accept T4, four-pin CFLs—were specifically designed for retrofit applications. The electronic ballasts that drive the lamps were mounted on steel beams that spanned the lobby. Figure 1 shows a sample CFL fixture, CFL, and electronic ballast removed from the Trade Center.

drilled a ventilation hole in each of the remaining new fixtures, suspecting that the lamps may have been overheating (see Figure 1).

Figure 1. Lamp fixture, CFL, and electronic ballast removed from the New York World Trade Center

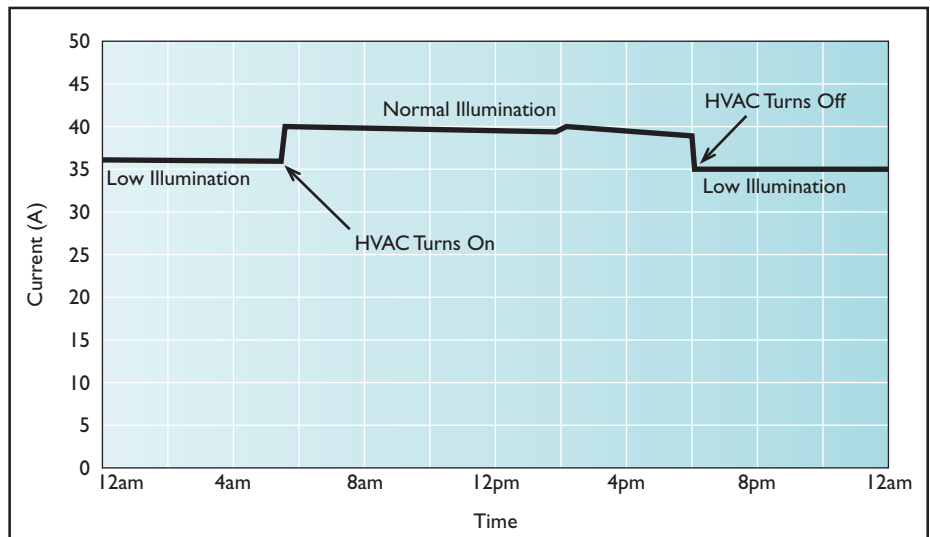
First, NYPA monitored the lighting panel serving the CFLs that dimmed during the night and discovered that the voltage at the lighting panel was about 117 AC volts, well within voltage limits for lighting circuits. NYPA investigators installed a powerline monitor at the lighting panel for several days to record voltage, current, and harmonic distortion. Reviewing the data stored in the monitor, they discovered that a decrease in current at the CFL lighting panel coincided with the building's HVAC system turning on and off. As shown in Figure 2, the CFL produced normal illumination when the HVAC was turned on in the morning, drawing a current of about 40 amps. However, when the

HVAC was turned off in the evening, the CFLs drew only about 35 amps of current, indicating low illumination.

Figure 2. Current measured at a lighting panel during a 24-hour period

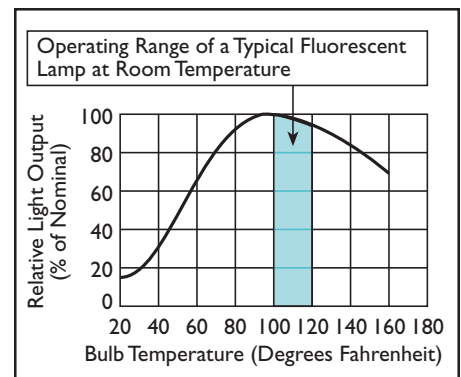
The effect of bulb temperature on the illuminance of a CFL is well documented. As shown in Figure 3, relative light output decreases (from the point of maximum

Figure 3. Relative light output of a typical fluorescent lamp based on bulb temperature (adapted from Barrow's *Light, Photometry, and Illuminating Engineering*, 1951)

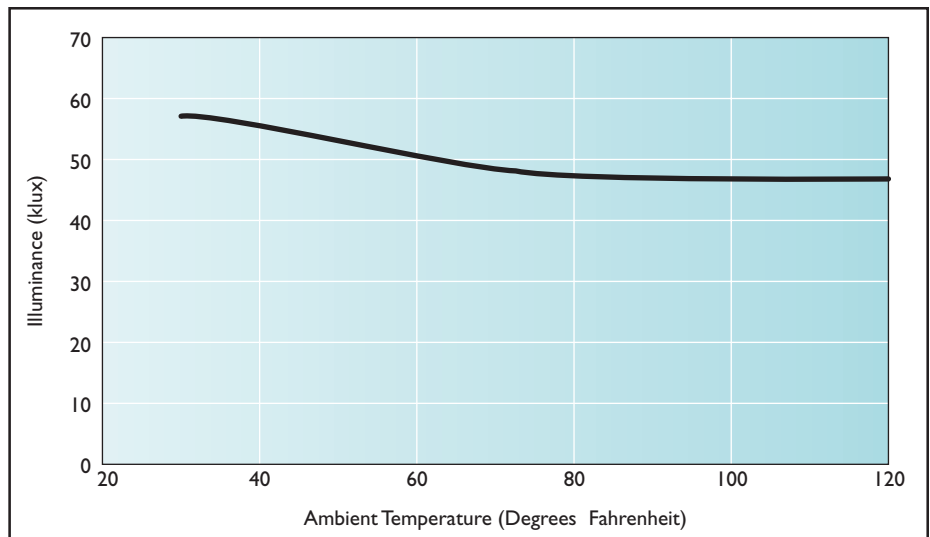
Figure 4. Illuminance of a tested CFL based on ambient temperature

light output) as the bulb temperature decreases. However, as shown in Figure 4, the ambient temperature had little effect on the illuminance of the CFL when the CFL was tested independently. In fact, as the temperature decreased from 120 to 30 degrees Fahrenheit (about 49 to -1.1 degrees Celsius), the illuminance increased. Changing the ambient temperature of the environmental chamber was simply not enough to significantly decrease the temperature of the CFL bulb. Therefore, the laboratory investigators suspected that the air flowing in the plenum was somehow cooling the CFL bulbs.

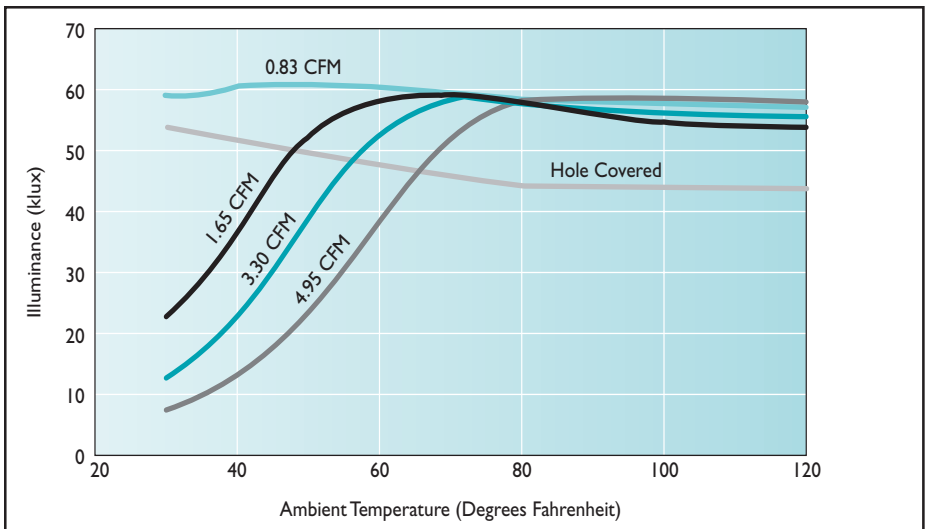
The results, shown in Figure 5, lend conclusive evidence that the cold airflow from the lobby plenum through the drilled ventilation holes and onto the lamps was causing the lamps to dim. The higher the rate of airflow through the hole in the fixture, the more the lamp dimmed. Figure 6 illustrates how the airflow affected the temperature of the CFL bulb much more than the ambient temperature alone (shown as “No Air Flow” in Figure 6).

Figure 5. Illuminance of a tested CFL for different rates of airflow based on ambient temperature

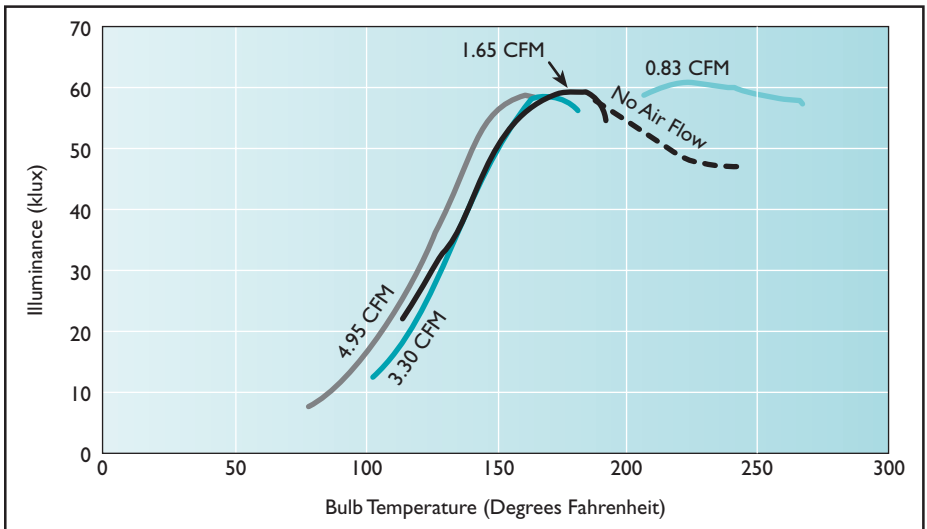
Figure 6. Illuminance of a tested CFL for different rates of airflow based on bulb temperature

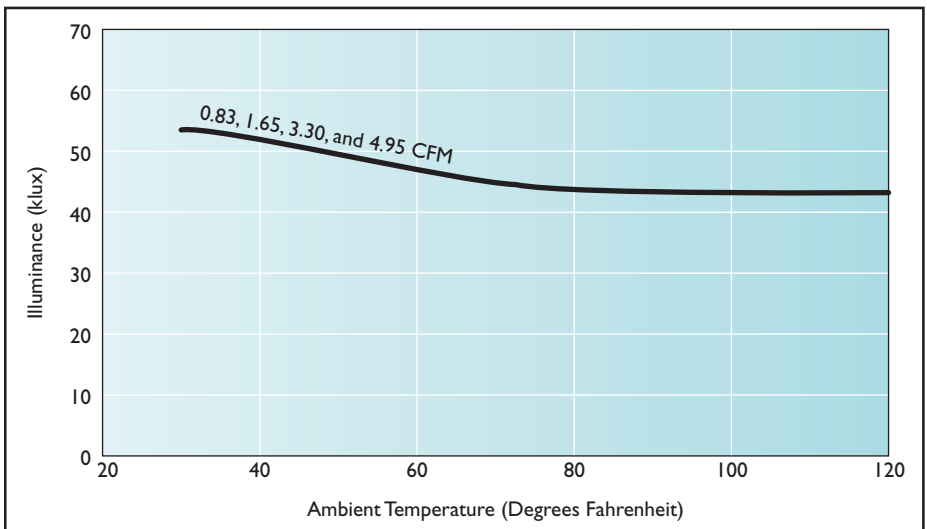
Figure 7. Illuminance of a tested CFL with the drilled hole covered for four different rates of airflow based on ambient temperature (identical results overlap)

covered the ventilation hole in the tested fixture. In the controlled environmental chamber, the solution was verified. Figure 7 shows the CFL illuminance at the four different rates of airflow. The illuminance-temperature curve is the same for all four rates, as indicated by the single line in the figure. Illuminance as a function of ambient temperature with the hole covered was similar to that shown in Figure 4, which shows the results of testing the CFL with the hole open and no airflow.

The research conducted at the University of Tennessee laboratory demonstrated that the holes in the CFL fixtures supplied a path for cold air to reach the CFLs, which are sensitive to direct cold airflow. To prevent this airflow, PEAC investigators

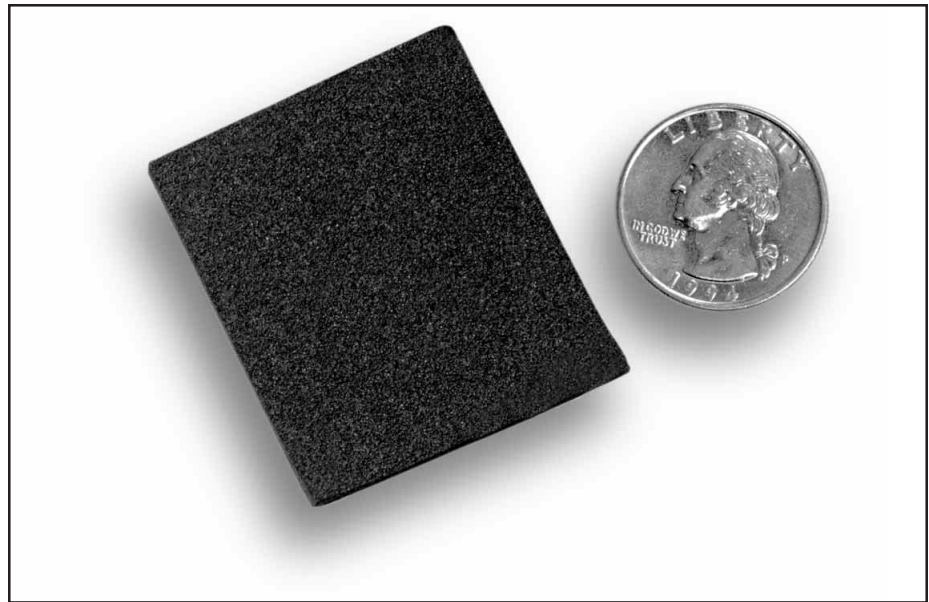
Figure 8. The solution: A neoprene gasket used to seal ventilation holes in the CFL fixtures

as the culprit of the dimming problems. Figure 8 shows one of the gaskets used in the lobby of the Trade Center.

After the solution to the CFL dimming problem was verified in the laboratory, NYPA recommended that the on-site contractor seal the ventilation holes drilled in the CFL fixtures. Heeding NYPA's recommendation, the on-site contractor ordered high-temperature neoprene gaskets with adhesive backs and installed them over the fixture holes. One cold night in New York City verified the effectiveness of the gaskets and exonerated power quality
