## Solving the Fast Clock Problem

### Background

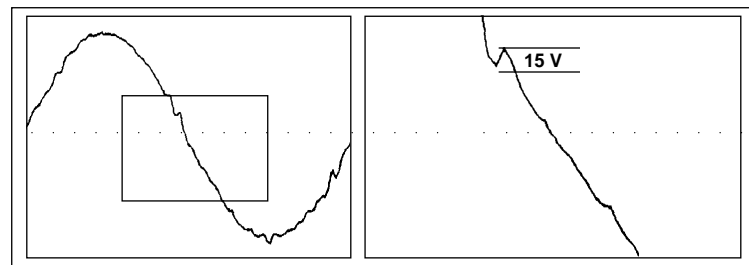
Figure 2.  
One of the Many Notches (15 Volts Peak-to-Peak) Discovered on the Sierra Blanca Power Lines

Some rural customers in Sierra Blanca, Texas, complained to the local utility company that their digital clocks were gaining up to two hours a night and awakening them with alarms too early in the morning. Troubleshooters for the utility borrowed the malfunctioning clocks and installed them in the company's Sierra Blanca office, where they operated perfectly. Company engineers then used a harmonics meter and an oscilloscope to check the local power lines. The oscilloscope revealed voltage oscillations at about 15 volts peak-to-peak (see Figure 2).

Monitoring the voltage at the substation, the engineers transferred different branch power lines to other feeders (backfed them), one by one. The problem disappeared when a particular branch power line was isolated. Later, the engineers discovered a partially open disconnect switch on the affected phase and confirmed that arcing between the contacts of the switch was distorting the sine wave.

At Sierra Blanca, the West Texas engineers discovered random capacitive arcing across the faulty disconnect, which created the oscillations in the power lines of a few rural customers. The oscillations causing their digital clocks to run fast were eliminated when the engineers properly closed the disconnect.

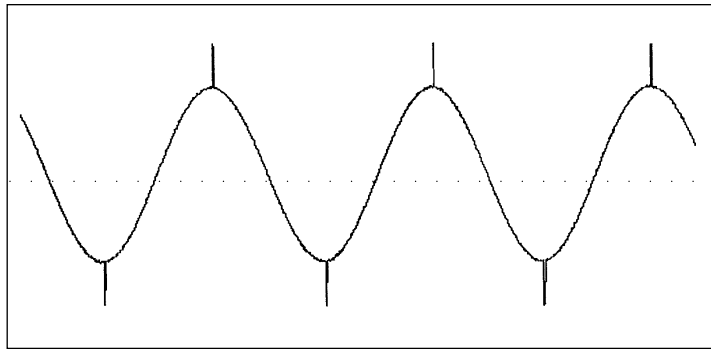
The Duke power monitors captured the disturbing waveform at one point along the distribution circuit (see Figure 3) and at an electrical outlet of a residence (see Figure 4). Duke engineers analyzed it and discovered another clue: The waveform occurred only when Step B of the capacitor bank at the substation was switched off. However, they could not yet pinpoint the exact source of the distortion making the clocks run fast.

Figure 3.  
Ringing on a 60-Hz Waveform Captured by the Duke Power Engineers on the Distribution Lines

The test results supported a theory that Duke Power had come up with back in Salisbury: The waveform was caused by periodic arcing. Engineers at Salisbury went to the capacitor banks at the substation, where they confirmed their theory. Arcing was causing a pulse event every few cycles of the 60-Hz sine wave. At each pulse event, the distribution circuits resonated, causing oscillation at the customer service transformer capable of disrupting the time-keeping of digital clocks.

Based on the signature of the disturbance confirmed by PEAC, knowledge of their substation equipment, and their experience, the Duke Power engineers were able to isolate the problem by inspecting circuits at the substation. They correctly deduced that the arcing was caused by a failing vacuum bottle in a capacitor bank breaker. When they located the problem vacuum bottle, it was blackened and close to failure. Service personnel replaced the vacuum bottle without disruption to Salisbury's electrical service, avoiding the costly situation of the vacuum bottle failing and disrupting service to the customers.

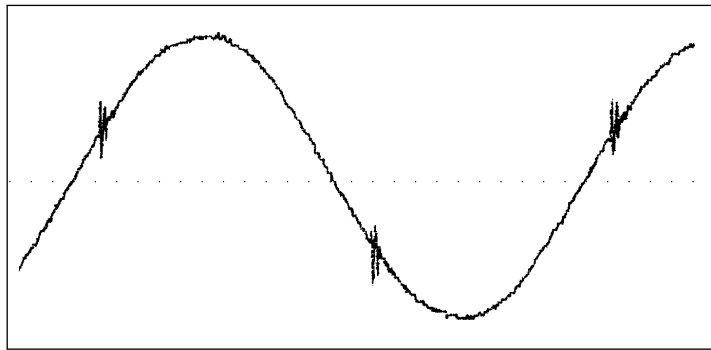
Figure 4.  
Ringing on a 60-Hz Waveform Captured by the Duke Power Engineers at a Residential Electrical Outlet

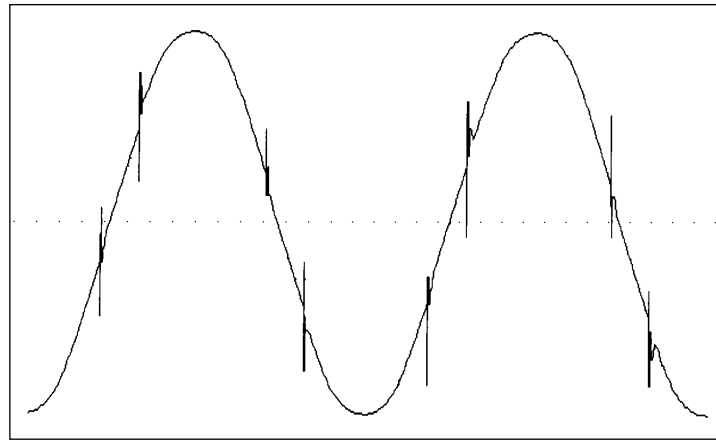
oscilloscope to his parents' home and recorded voltage notches at the outlet feeding the clock. Because he saw the same voltage notches at the main breaker, he believed that they were coming from outside the house. He faxed the engineers at Wisconsin Electric a copy of the voltage waveform from the main breaker, similar to the waveform shown in Figure 5. The notches in the waveform reminded the engineers of a waveform seen at the site of an industrial customer, where a six-pulse, AC-to-DC converter was causing voltage notching four times per second and ringing at about 10 kHz.

Because the voltage notches were at the meter even when the main breaker was open and similar impulses were at neighboring meters, the Wisconsin Electric personnel removed a neighbor's meter as a test. The voltage notches at the clock vanished. By switching the neighbor's breakers off one by one, the search for the disturbance was narrowed to an electronic air ionizer.

Waveform Captured at Residence of a Wisconsin Electric Customer

In Wisconsin, the problem was solved simply because the neighbors volunteered to forego using their air ionizer. The Wisconsin electric utility had its service representatives ask everyone with fast-running clocks powered by a common service transformer whether they had an electronic air ionizer. This turned out to be cheaper than tracking each recurrence of the problem.
