Solving Power Quality Problems in Medical Imaging Systems

Two Problems

Two Solutions

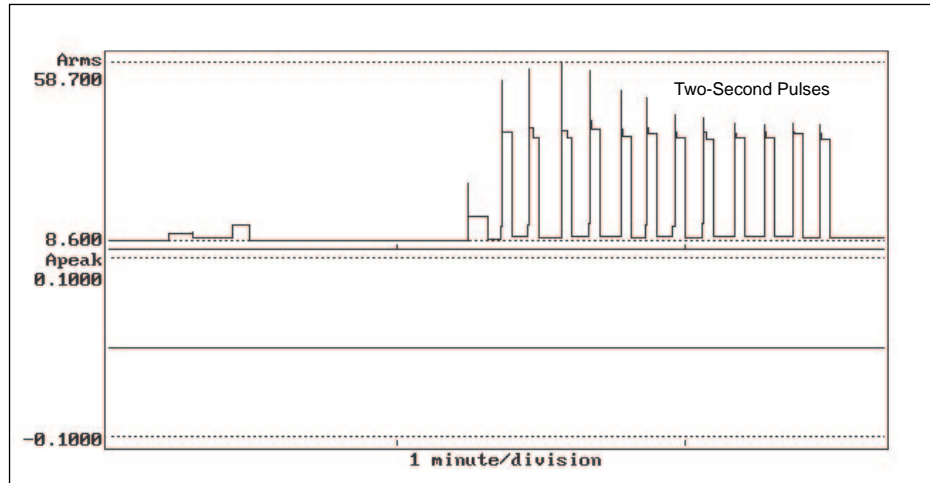
Figure 2. RMS Current of a Typical CT Scanner During a Scan

Like that in the conventional X-ray machine, the X-ray tube of a CT scanner switches on and off repeatedly. However, as shown in Figure 2, the rotating X-ray tube in the CT scanner draws current in pulses lasting about two seconds, whereas the current pulses of a conventional X-ray tube last only about four cycles (70 milliseconds). The longer, two-second pulse of the CT scanner's X-ray tube makes its imaging process more vulnerable to power disturbances. For example, a voltage sag occurring during one of these pulses can cause such severe degradation of the X-ray image that it cannot be used for diagnostic purposes, even if the microcomputer processing the image is not interrupted. Or, if the supply voltage sags below the scanner's undervoltage protection limits, the scanner may reset in the middle of a procedure, losing all the images stored in its memory.

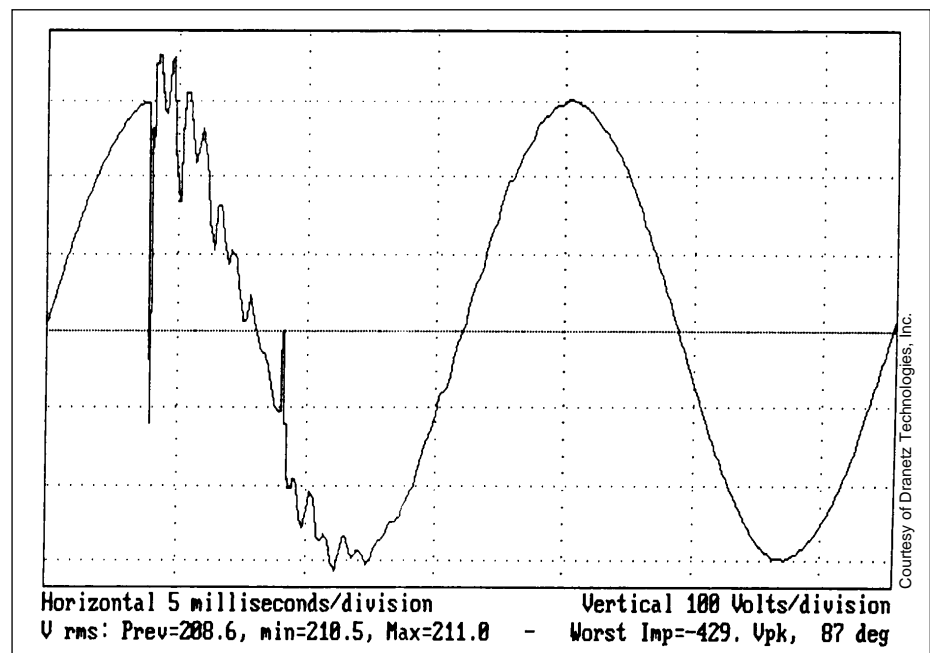
Figure 3. Ringing Transient Recorded at the Nevada CT Scanner

In another medical clinic in Nevada, a CT scanner was experiencing repeated computer lockups and component failures. The power was brought to the CT scanner by a 480-volt service feeding a 480-to-208-volt isolation transformer. Using a power monitor, the medical equipment service company identified the cause of the failures: a voltage transient, shown in Figure 3, produced by the local utility switching on a power-factor-correction capacitor bank, located only a block away. The hospital's isolation transformer had little effect upon the ringing transient.

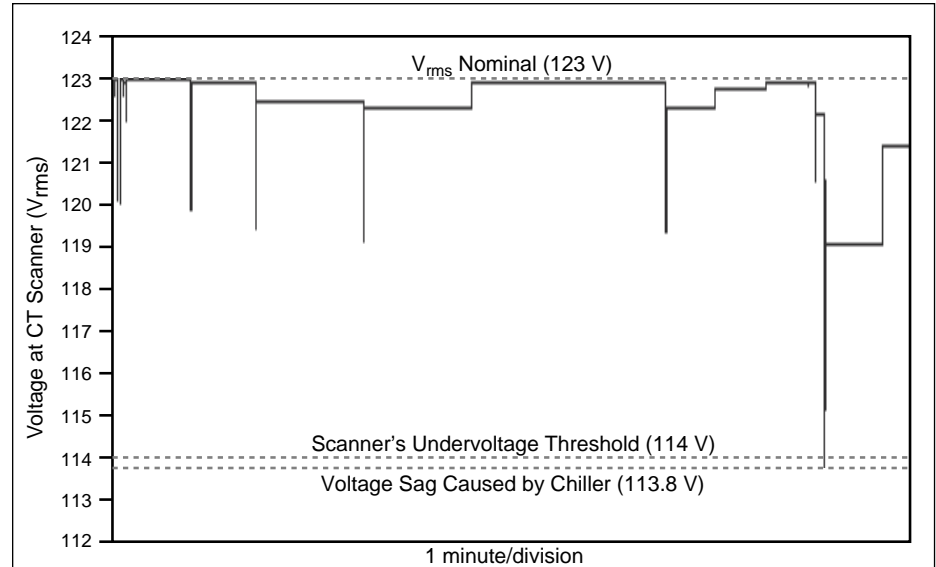
Figure 4. RMS Voltage Recorded at the Kansas CT Scanner

By this time, the director of maintenance for the Kansas hospital had pinpointed another possible cause for the scanner failures: The scanner shutdowns most often occurred when

the chiller in the hospital's air conditioning system started. The maintenance director solved the problem by manually starting the chiller only when the CT scanner was not in use. However, this solution was less than ideal—manually starting the chiller overrode the hospital's energy-management system, significantly increasing the facility's energy costs.

University. Jewell monitored the voltage at the CT scanner to confirm that the voltage sags corresponded to the starting of the chiller. Figure 4 shows the RMS voltage at the CT scanner. Most of the voltage sags were caused by the normal operation of the CT scanner. These sags dipped to no less than 119 volts. However, the sag caused by the chiller-starting dipped to 113.8 volts. Jewell determined that the scanner's undervoltage trip threshold was set too high (at 114 volts) by the installer, who misunderstood the
