Following the Trail of Destruction

By Brad Conatser, Doni Nastasi, and Kermit Phipps, EPRI PEAC Corp., Knoxville, Tenn.

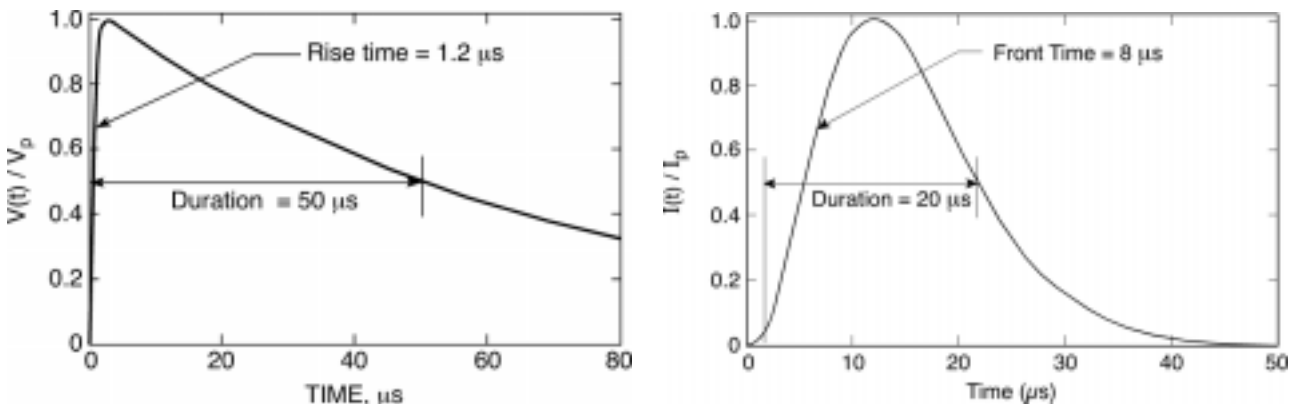
Fig. 1. ANSI/IEEE Standard C62.41 Combination Wave (open-circuit voltage, left, and short-circuit current, right).

Based upon field experience and testing, Standard C62.41 proposes testing with a waveform that represents a surge resulting from lightning directly impinging upon or coupled into the power system (called a "combination wave"). Fig. 1, on page 62, shows the waveform of the open-circuit voltage and short-circuit current. Three characteristics specify the waveform: rise time (or front time, in the case of short-circuit current), duration, and amplitude.

During testing, the rise time and duration are held constant according to the ANSI/IEEE definition. On the other hand, varying the amplitude by ramping it up in 500V increments for each trial can cause equipment failure.

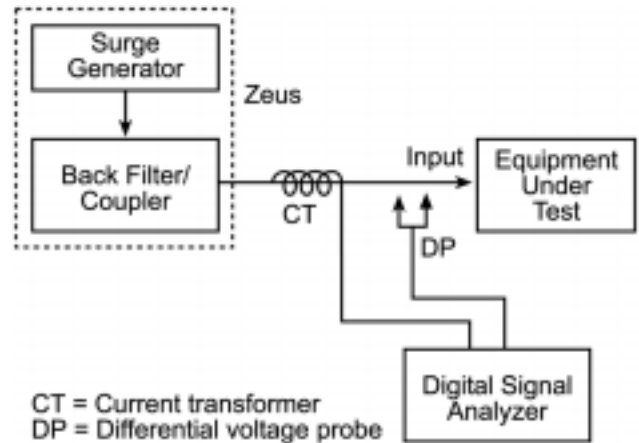
intended to cause damage so investigators can correlate observable and measurable effects with a known cause. Fig. 2 shows a simplified diagram of the setup used to surge test equipment. Zeus is composed of a surge generator to supply the surge voltage and current and a back filter/coupler to prevent surge current from feeding back into the power source and to couple the surge into the equipment under test. A digital signal analyzer monitors and records

Fig. 2. Simplified diagram of test setup for surge testing equipment.

the voltage and current at the equipment power port.

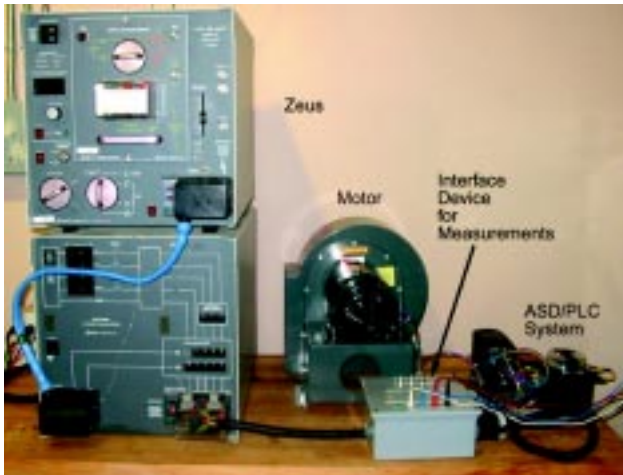
During the first stage of the project, about a dozen motor-and-control systems were tested. Each systems was composed of a motor, an adjustable-speed drive (ASD), and a programmable logic controller (PLC), as shown in **Fig. 3**.

Fig. 3. Test setup for surge testing a motor-and-control system.

The PLC was connected to 3-phase voltage via a step-down transformer, which supplied single-phase 120V power.

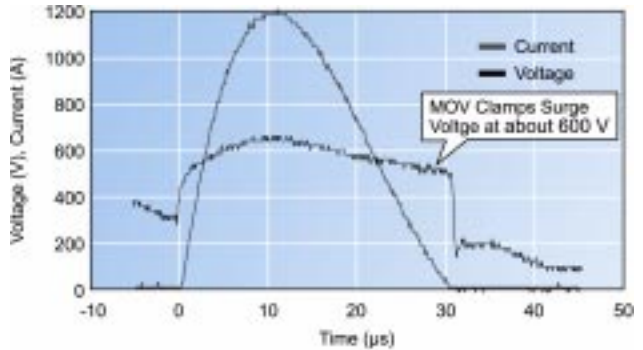
Fig. 4 and **Fig. 5**, on page 66, show examples of recorded waveforms during surge testing a motor-and-control system. **Fig. 4** shows the results of a trial where the current peaked at 1,200A. MOVs inside the ASD were able to clamp the voltage at about 600V. In this particular trial, the equipment survived the surge.

Fig. 4. Recorded waveforms during a single trial with a peak current of 1,200A.

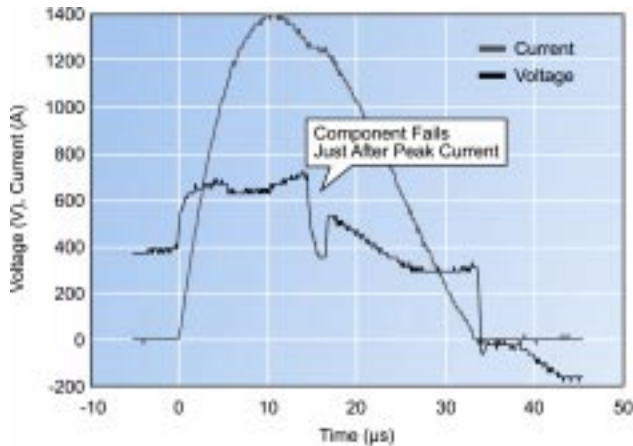
Fig. 5 tells a different story. During this trial, the current peaked at 1,400A. As shown in the voltage trace, the MOV clamped the voltage, but an unidentified component failed just after the peak current.

Fig. 5. Recorded waveforms during a single trial with a peak current of 1,400A.

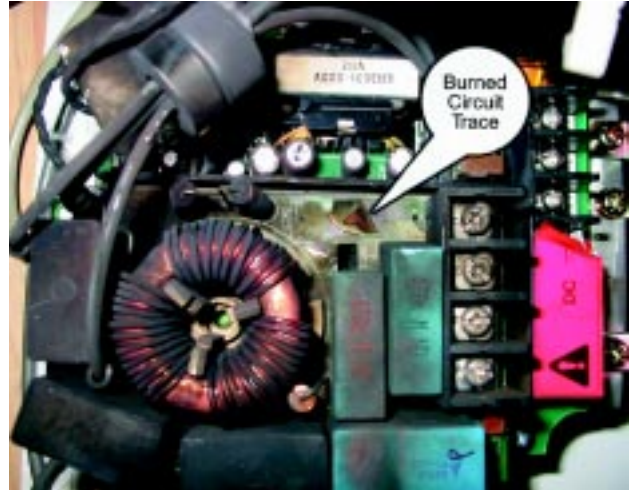
Fig. 6 shows one of the ASDs that failed during surge testing. The catastrophic failure of a filter capacitor resulted in an explosion followed by smoke billowing from the ASD vents. The failure of MOVs and filter capacitors is *not* an unexpected consequence of a strong surge applied to equipment with these components in the front end. Note the soot remaining on the components (near the bottom left) result-

Fig. 6. Damage caused by a surge.

ing from the explosion of the filter capacitor. Also note the burned circuit trace resulting from excessive current—revealing evidence about the mode of failure.
