## Solving the Fast Clock Problem

### Background

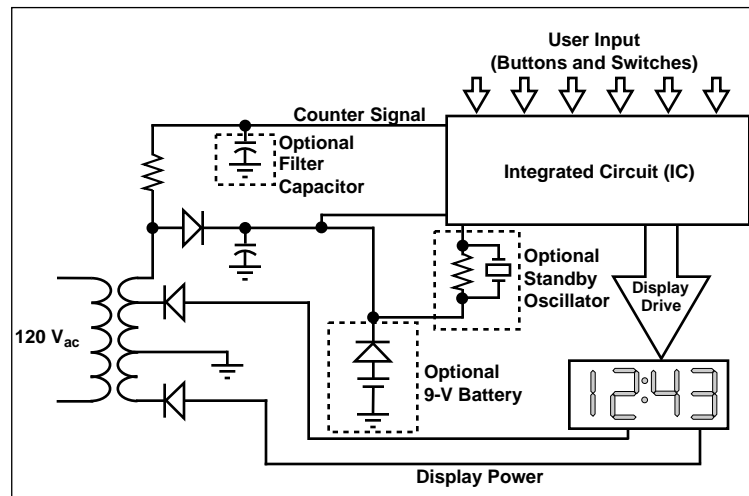
Figure 1.  
Schematic Diagram of a Typical Digital Clock

Here's how the problem arises. The counter of a digital clock converts the incoming 60-Hz sine wave into a square wave that it uses for its timing reference. Each time the incoming sine wave completes 60 cycles, the counter registers one count and advances the clock by one second. Some oscillations or notches on the sine wave can trigger the counter, causing it to count at two or three times its normal rate (see Tutorial, back page).
